Technical guidance sheet 2.1

Physical protection of battery systems

Solar
Victoria

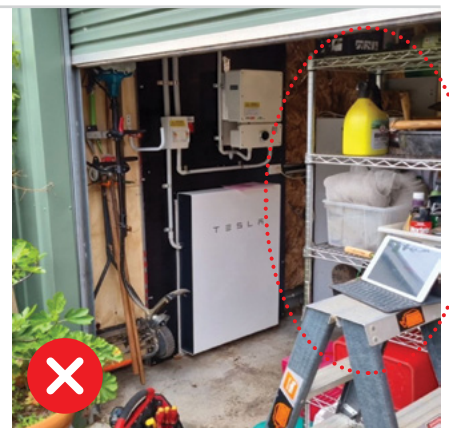
Figure 1.1:
Non-fixed shelving is not adequate mechanical protection for a battery system installed in an area accessible to cars.

Non-fixed/movable benches and cupboards may not provide suitable protection, as the homeowner could decide to move them in the future.

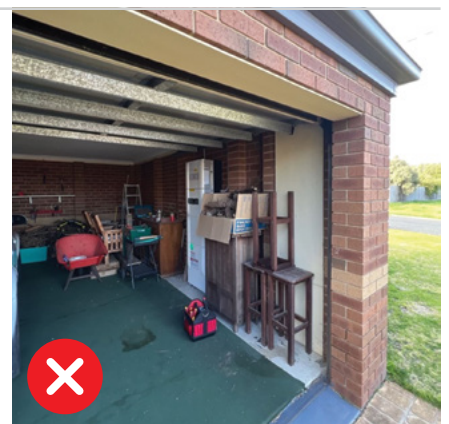
Figure 1.3:
A vehicle could enter into this space, meaning that fixed vehicle mechanical protection would be required regardless of any non-fixed objects that could be installed.

Additionally, if the area in question could allow a vehicle to enter the space (regardless of the homeowner's non-fixed objects) suitable fixed vehicle mechanical protection must be installed.

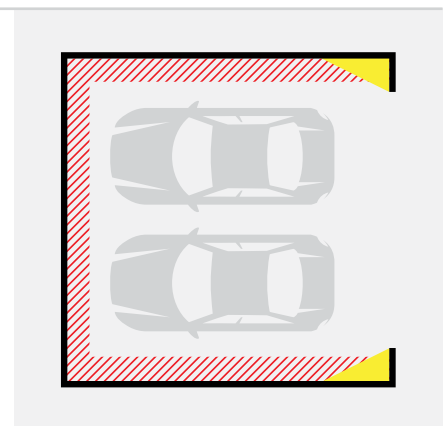
Figure 2.1:

Diagram demonstrating mechanical protection afforded by garage pillar walls for a standard double garage 6m x 6m and standard single garage 4m x 6m.

Area requiring additional mechanical protection (such as a bollard)

Area deemed protected by the garage pillar, not requiring additional protection

Where the battery system is located in the front corner of a typical 6m long garage and is protected by a solid front pillar or wall, it is reasonable to expect vehicle impact could not occur. A bollard therefore may not be required in this location (see Fig 2.1).

Note: As a guide, the protected area is calculated at a ratio 1:2.5 i.e. a 500 mm garage pillar would allow an area of 1250mm protection along the wall.

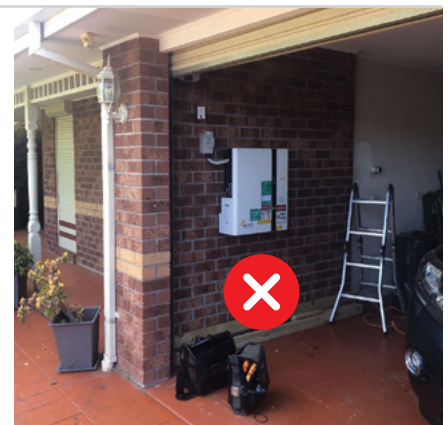
Figure 2.2:

The battery is too far away from the front corner of the garage and would require additional mechanical protection to be compliant.

If the battery system is set further back than the area afforded protection by the garage pillar, additional protection may be required.

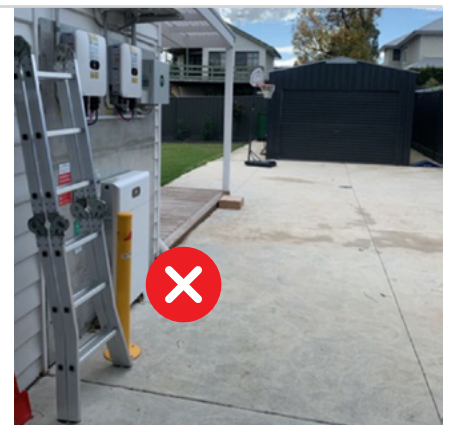
Figure 3.2:

As noted in Figure 3.1, there is adequate area for a car to drive beyond the edge of the battery, this requires additional mechanical protection be installed on the trailing edge of the battery.

As such, an additional bollard would need to be installed near the trailing edge of the battery system observed in this example to ensure adequate mechanical protection from vehicle strike.

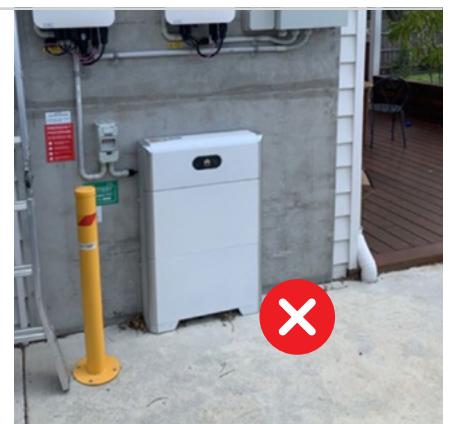
Figure 3.3:

The absence of trailing edge protection in an area accessible by vehicles makes this system non-compliant.

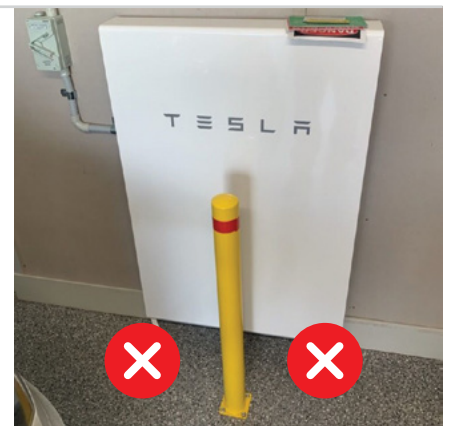
Figure 4.1:

The following system provides no protection against a car-strike on the left or right side of the battery and is therefore not compliant.

The centre placed bollard is inadequate to protect against potential vehicle strikes on the left and right-hand sides of the battery. Suggested compliant protection for this example may include the installation of two additional bollards (either side of the battery) or a U-shaped bollard system installed around the front of the battery system.

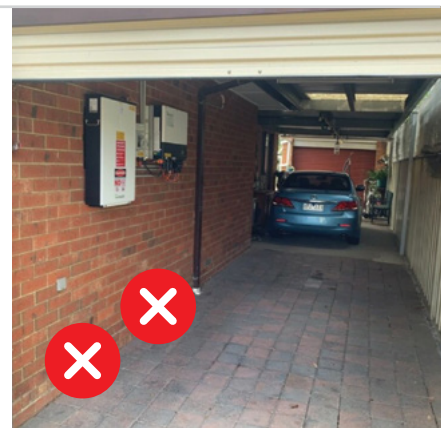
Figure 5.1:

The battery here requires mechanical protection as it would be possible for a van to enter this driveway and subsequently strike the battery.

In these examples, an attempt has been made to install the battery systems higher than the bonnet of the homeowner's (current) vehicle to try and mitigate potential vehicle strike. This may not provide adequate protection for a range of potential scenarios, such as a larger vehicle (e.g. an SUV) reversing in, or visitors with different car shapes (e.g. vans, utes).

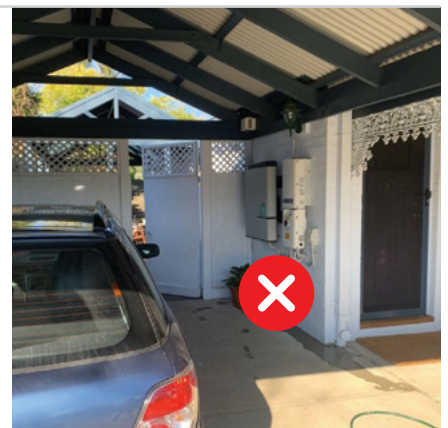
Figure 5.2:

Despite being above the ground, this battery is clearly within the range of the blue car shown in the image, particularly if reversing into the driveway. As such, further mechanical protection is necessary.

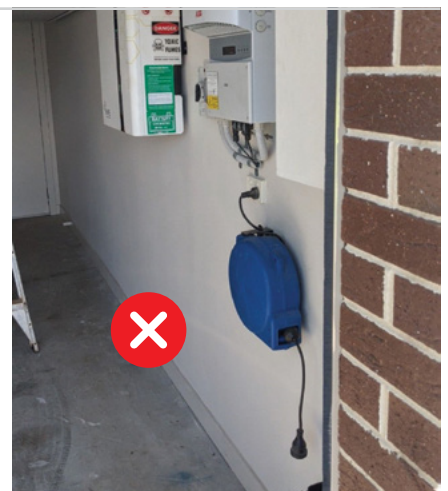
Figure 5.3:

Similar to Figure 5.1, this is not high enough to be out of the range of vans or large cars such as SUVs.

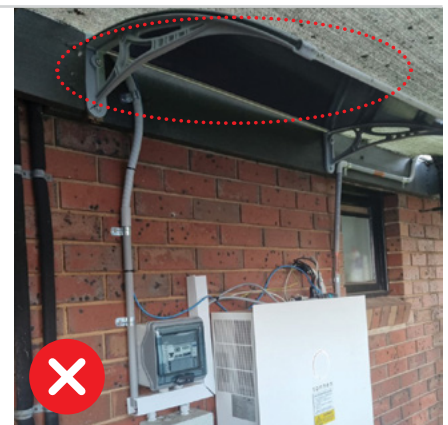
Figure 7.2:

Due to the IP30 rating, the whole battery is required to be within 30 degrees of a waterproof overhang or veranda. This is not occurring in this image – the veranda is too small.

As the electrical equipment has no water ingress protection rating, in this example the entire piece of equipment would need to be located within 30 degrees of an adequately waterproofed veranda or overhang (as per AS/NZS 3000:2018 Clause 4.1.3).

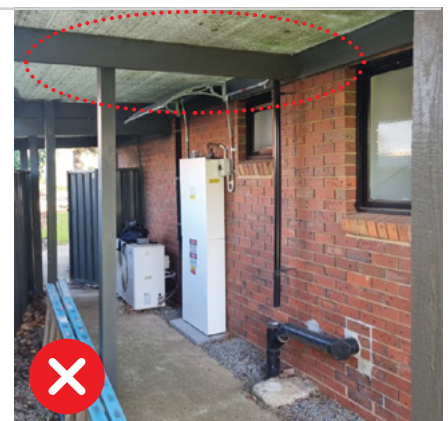
Figure 7.3:

The large green roof above the battery system is made from shade cloth, which is not waterproof and does not provide appropriate water ingress protection to the battery system.

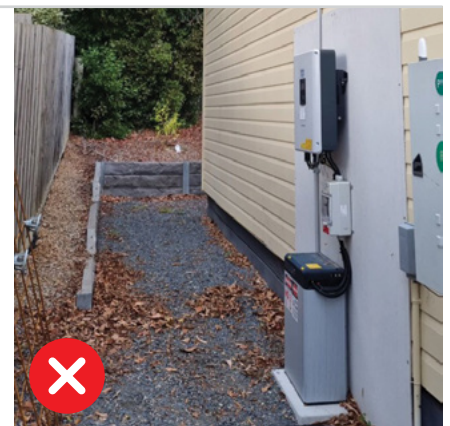
Figure 8a:

This system has no protection from direct sunlight or moisture, making this system non-compliant with manufacturer's instructions.

The RESU battery pack is rated at IP55 and thus can be installed outdoors as well as indoors. However, if installed outdoors, do not allow the battery pack to be exposed to direct sunlight and moisture.

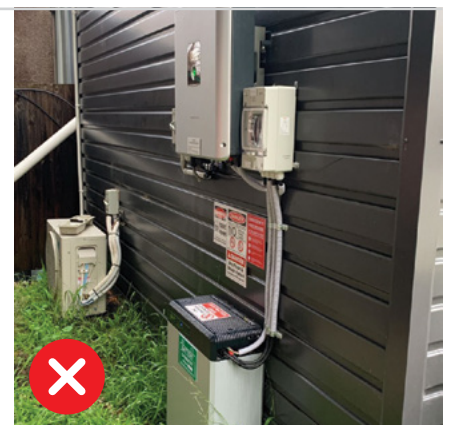
Figure 8b:

Like the system in 8b, no protection from sunlight or moisture has been provided for this battery system.

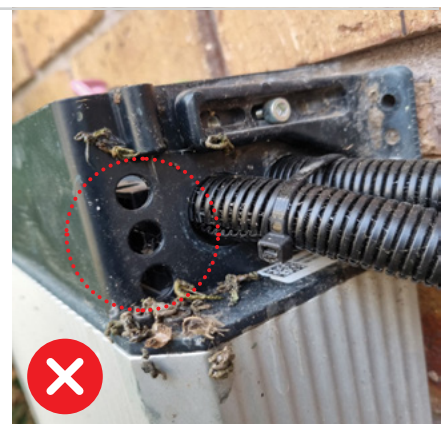
Figure 9c:

In this example the unused cable entries on the left of the battery system have not been sealed to prevent the ingress of flora and fauna.
